**REPORT ON STRUCTURAL HEALTH MONITORING, REPAIR  
METHODOLOGY FOR LEAKAGES AND CRACKS REPAIRS  
FOR  
HOSTEL BUILDINGS A-F BLOCK AT DIIACT, GANDHINAGAR**

HOSTEL BUILDINGS A-F Blocks

**Date: - 05-05-2026**

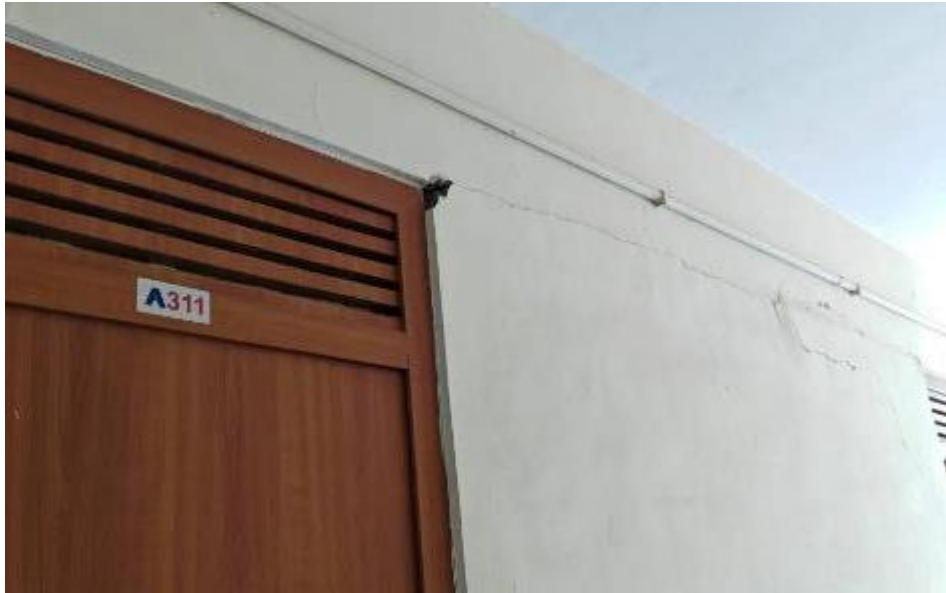
Cracks at beam Bottom Level

## 7. Repair of Cracks in Beam Bottom and Wall Junction

- **Expose the Joint:** Use a chisel or power tool to remove the loose, cracked plaster. Create a clean, V-shaped groove along the junction of the beam bottom and the top of the brickwork.

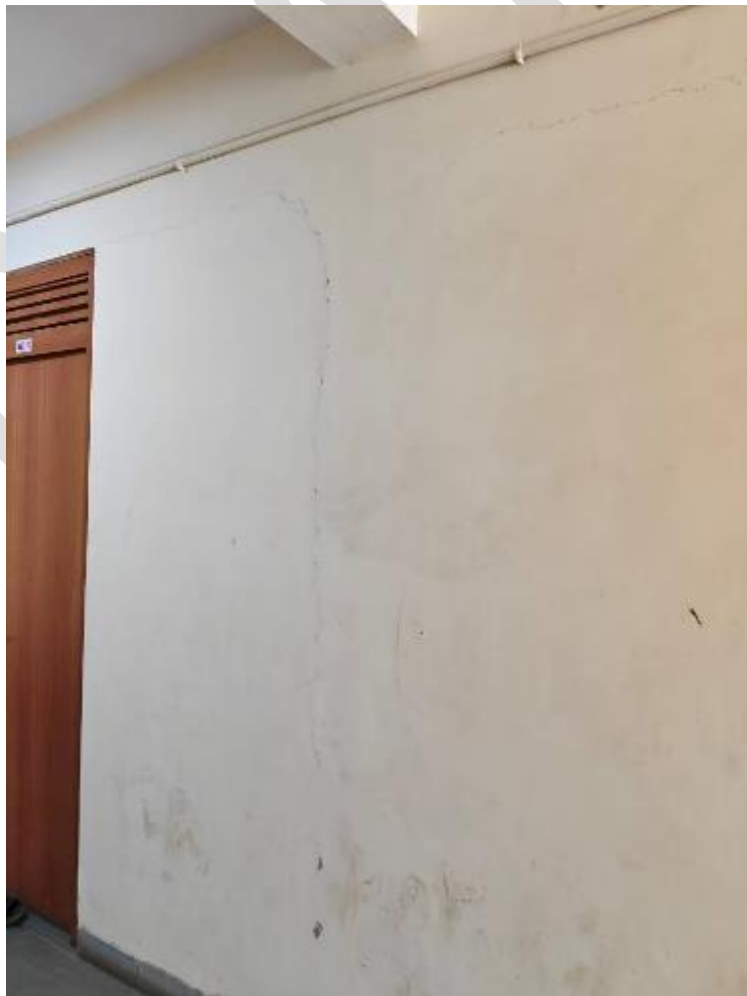
Cracks at beam and masonry junction Level

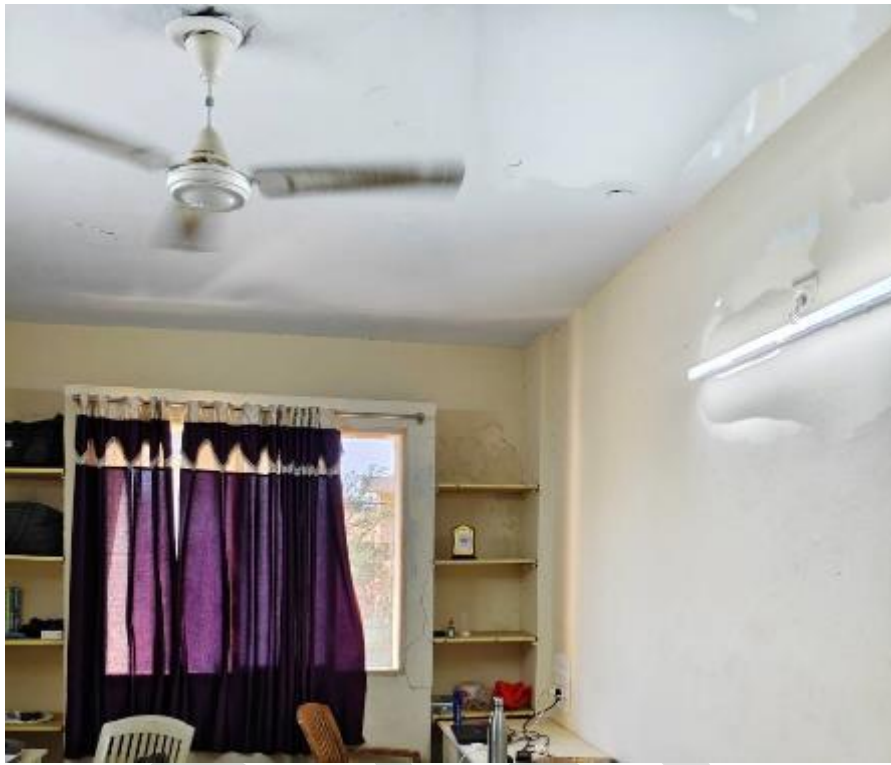
Slab concrete spalling off due to corrosion of steel and wall cracks at wall Beam junction.

- **Concrete Chipping:** Chip away all loose, delaminated, damaged, and carbonated concrete cover. Fully expose the corroded reinforcement steel bars, extending the excavation up to 20 mm completely beyond the main reinforcing bars to provide clear all-around working clearance.

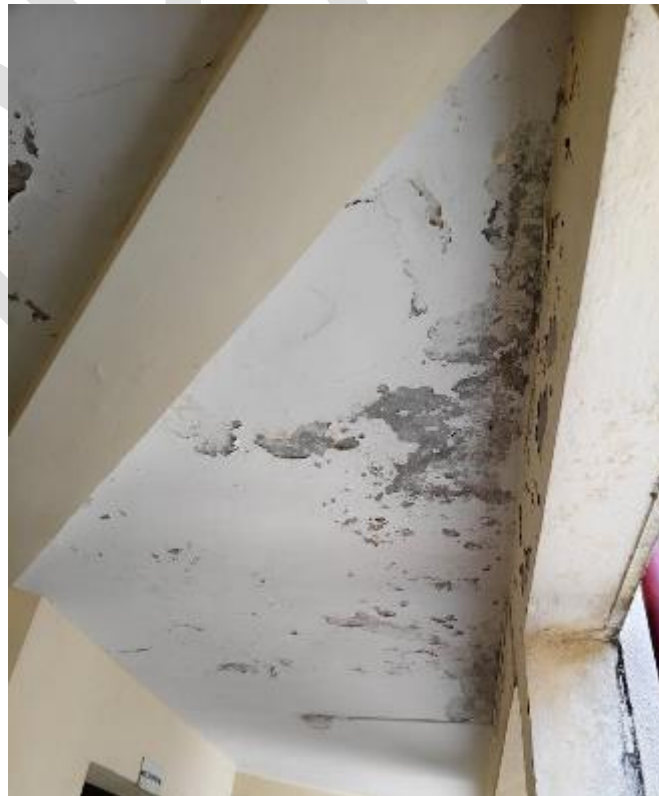
Past Dampness in Ceiling outside Washroom of Hostel Buildings

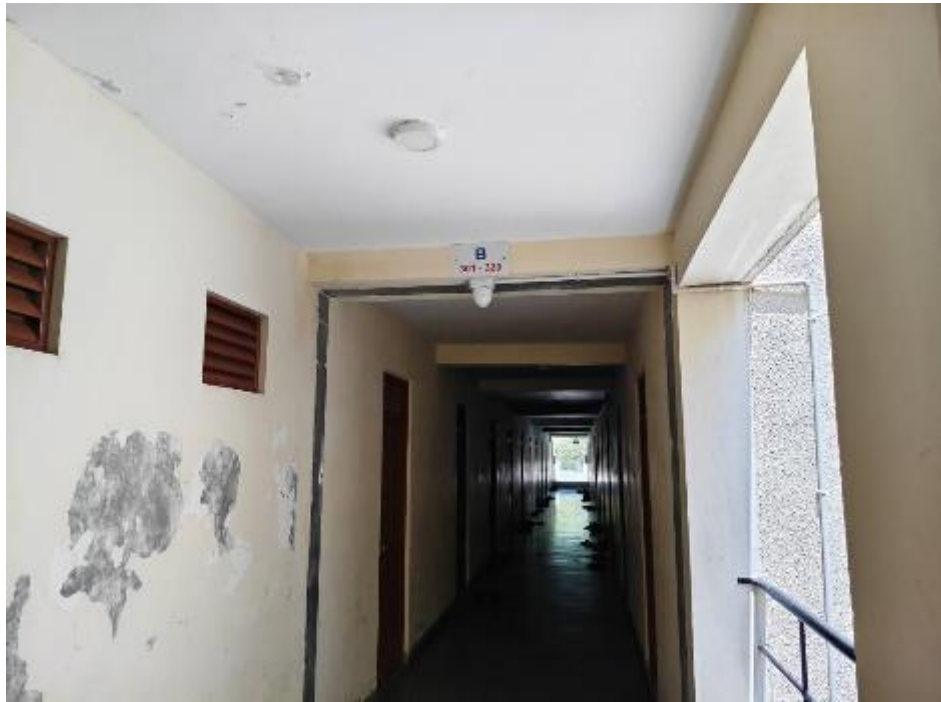
Dampness outside Washroom of Hostel Buildings.

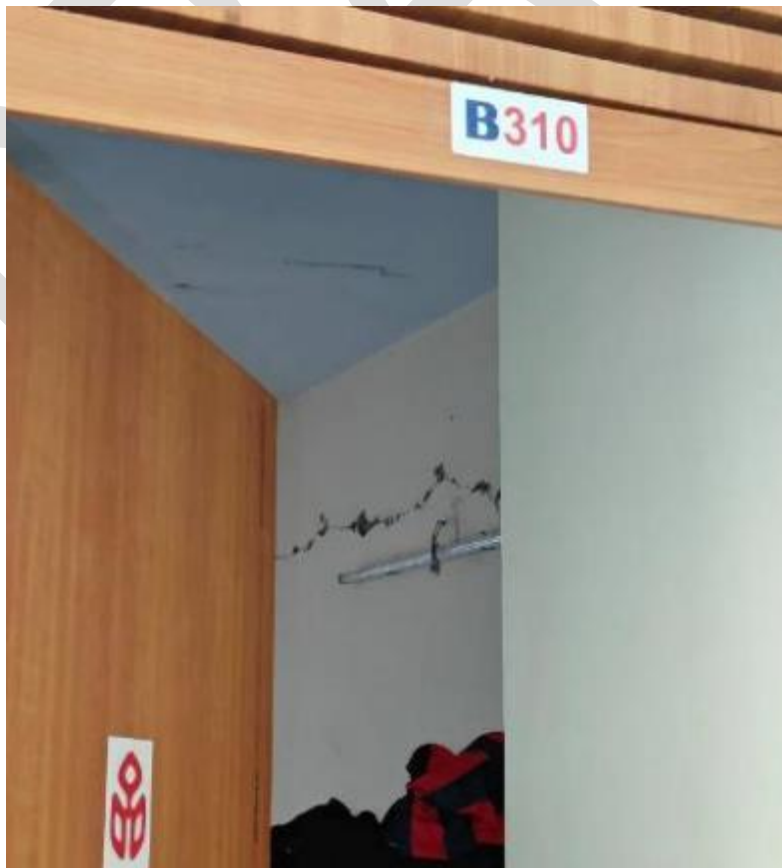
Non-structural Cracks at top floor of Hostel Buildings.

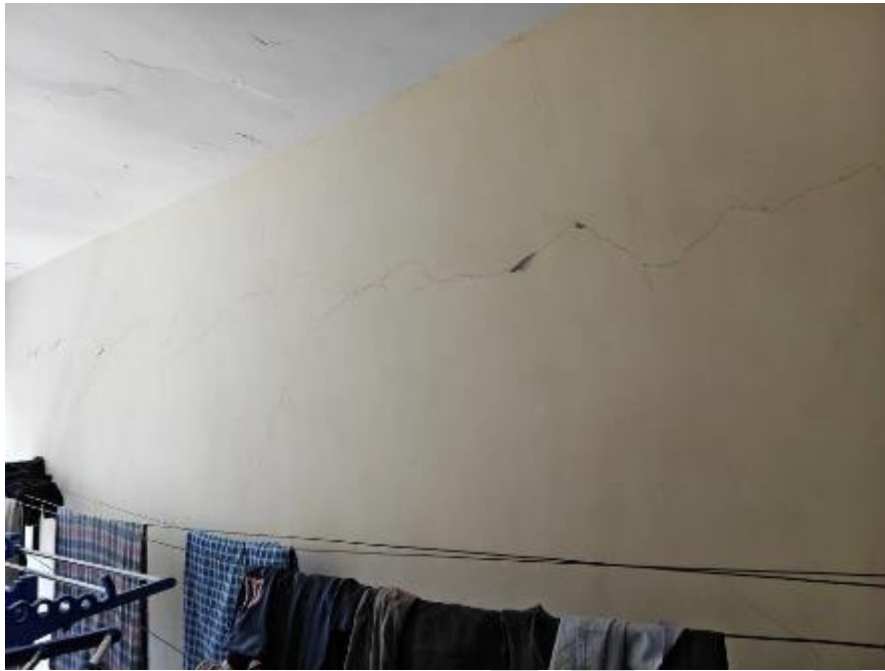
Slab concrete spalling off due to corrosion of steel and wall cracks at wall Beam junction.

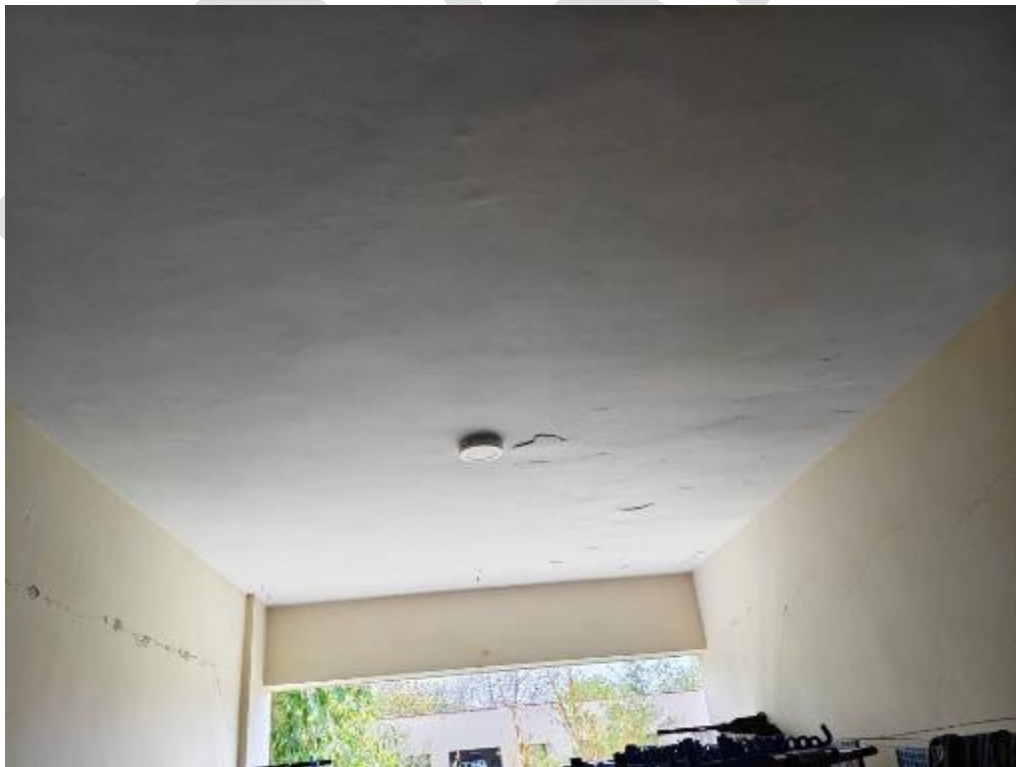
Slab concrete spalling off due to corrosion of steel and wall cracks at wall Beam junction.

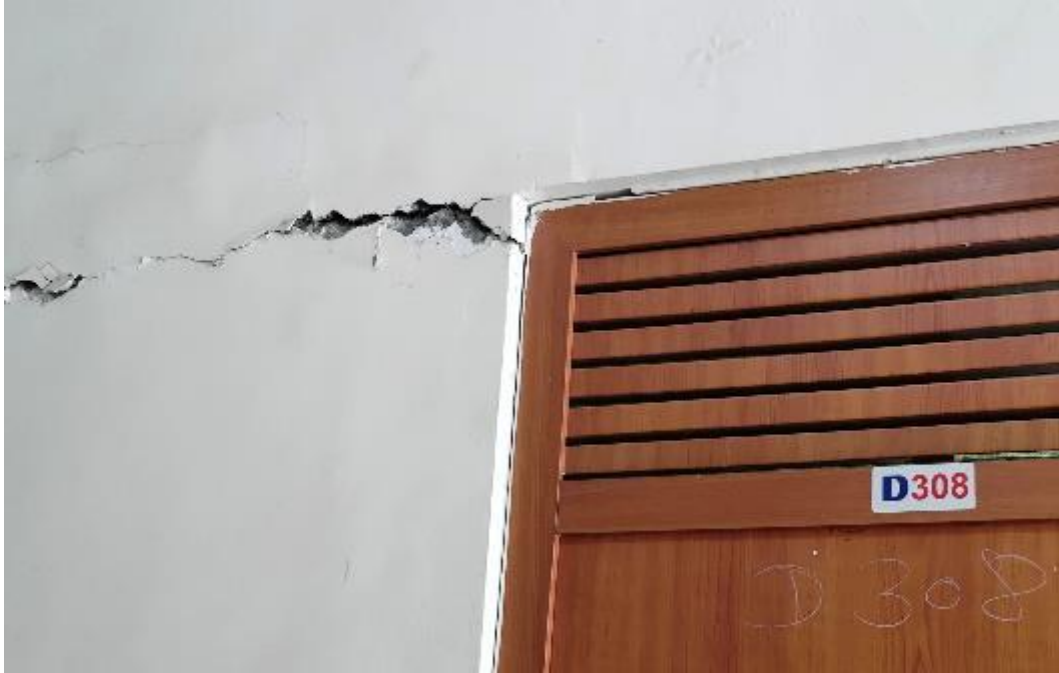
Non-structural Cracks at top floor of Hostel Buildings.

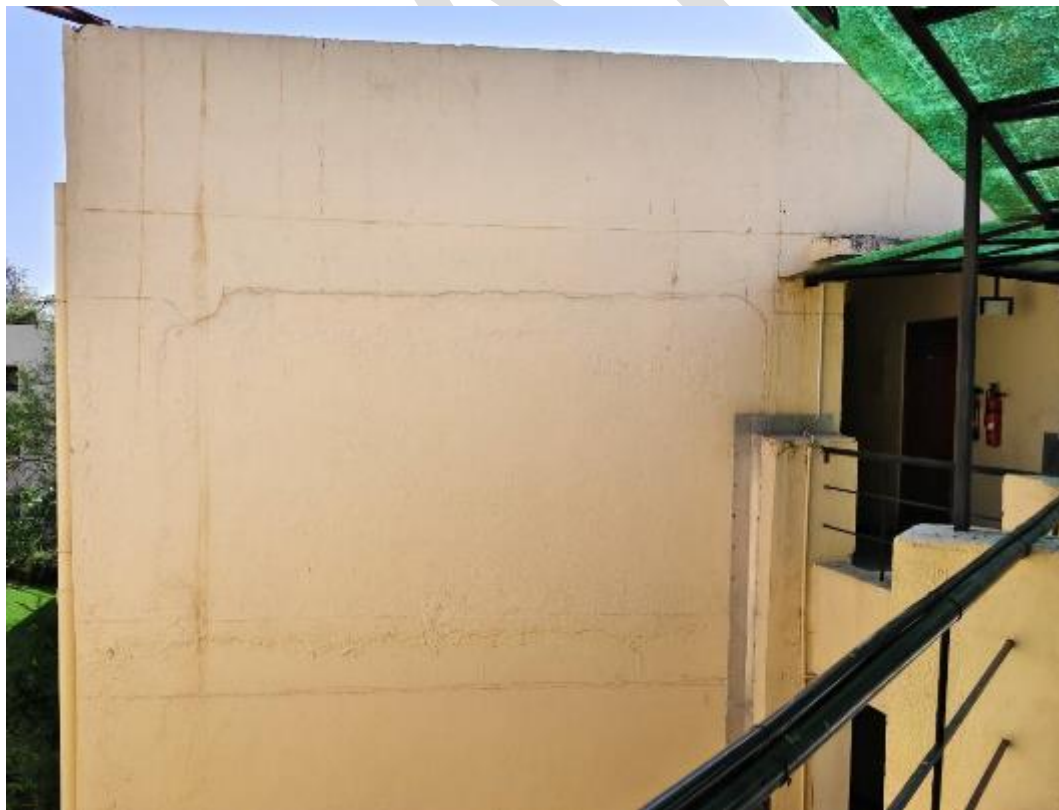
Non-structural Cracks at top floor of Hostel Buildings.

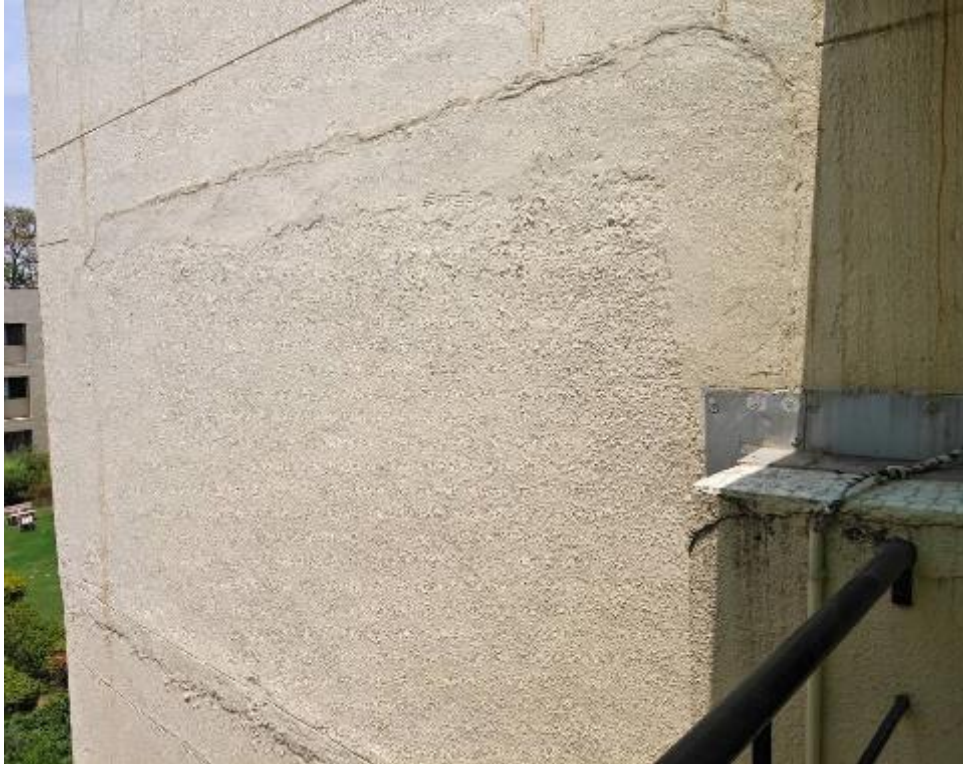
Previously repaired of wall plaster and structure.

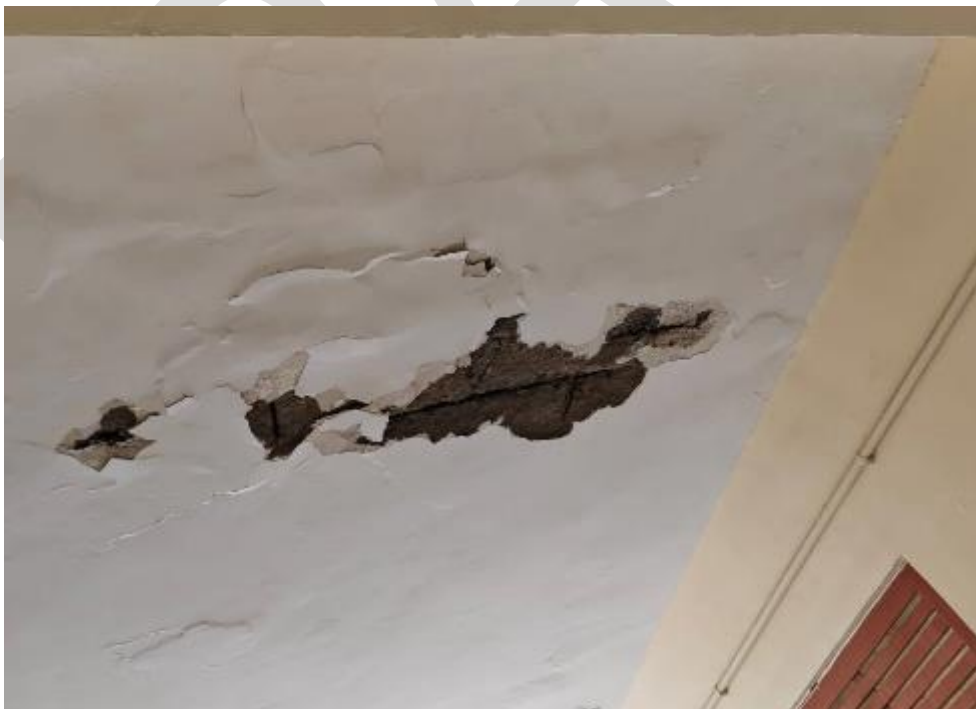
Slab Concrete spilling off due to corrosion of steel

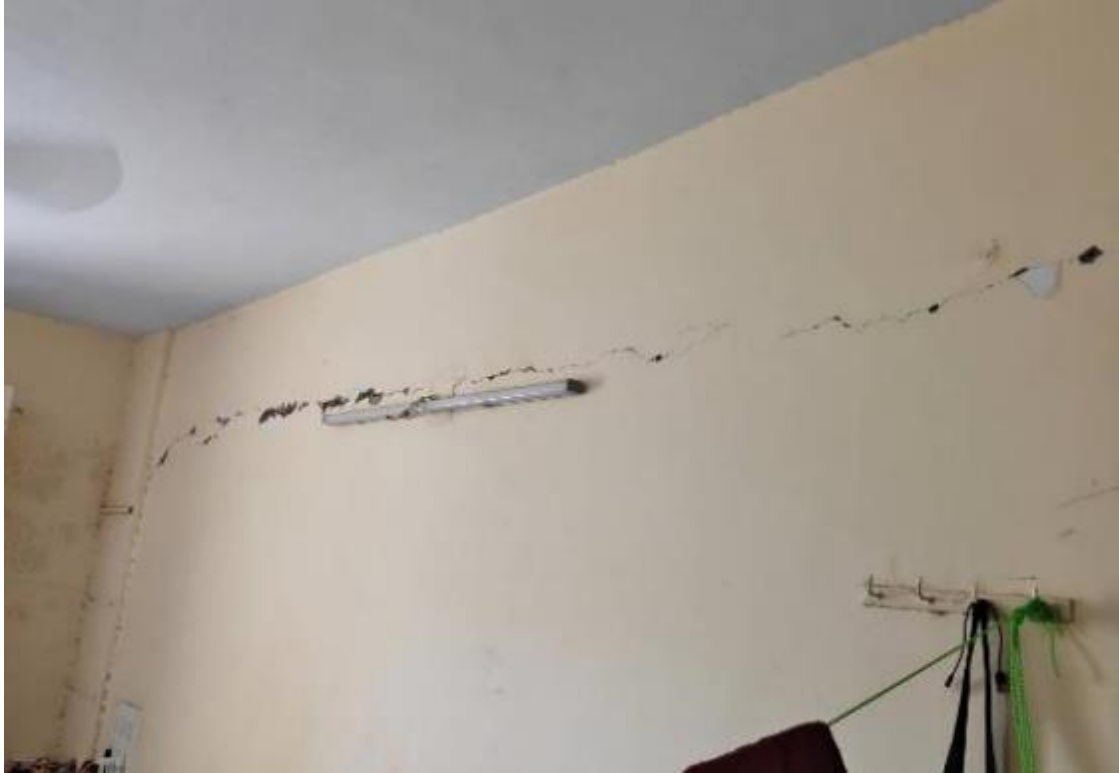
Non-structural Cracks at top floor of Hostel Buildings.

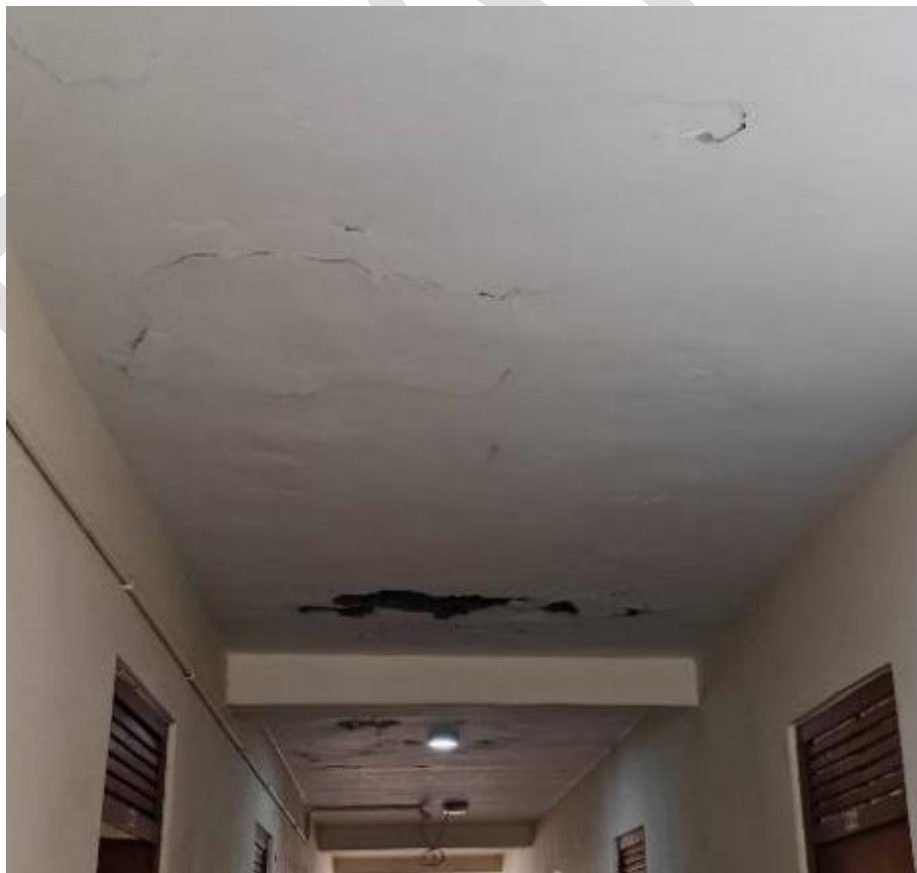
Slab Concrete pill off due to corrosion of steel

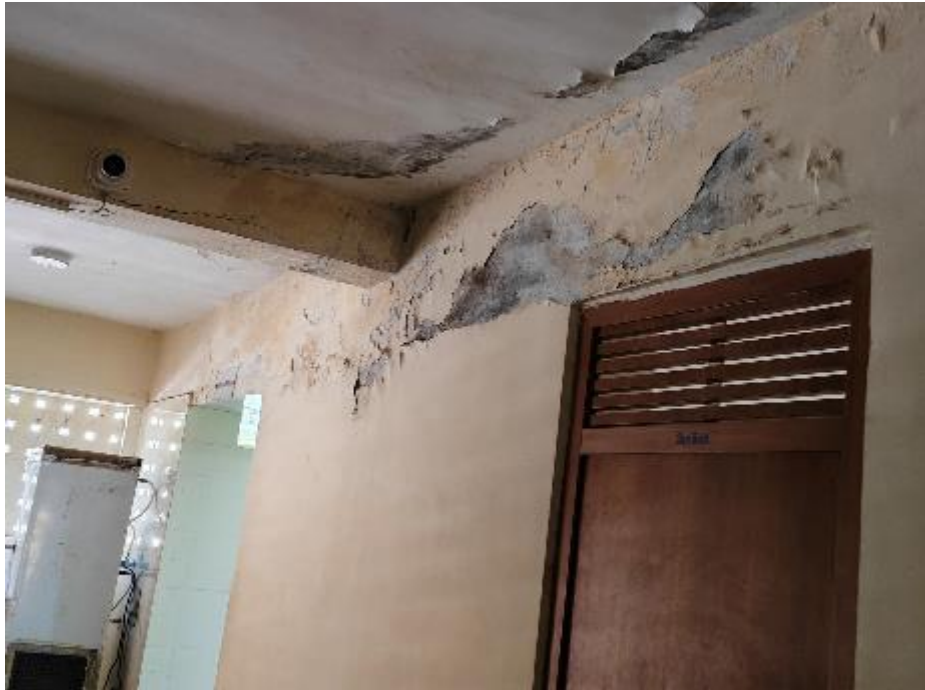
Leakage near Toilet block

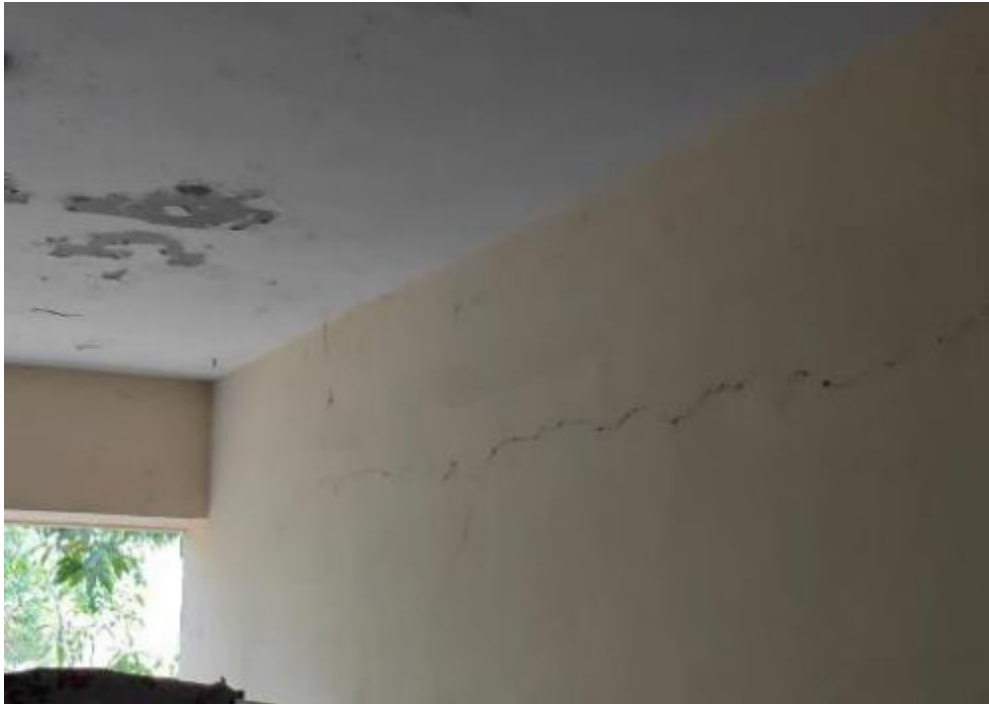
Dampness and corrosion in Slab & Crack below Beam.

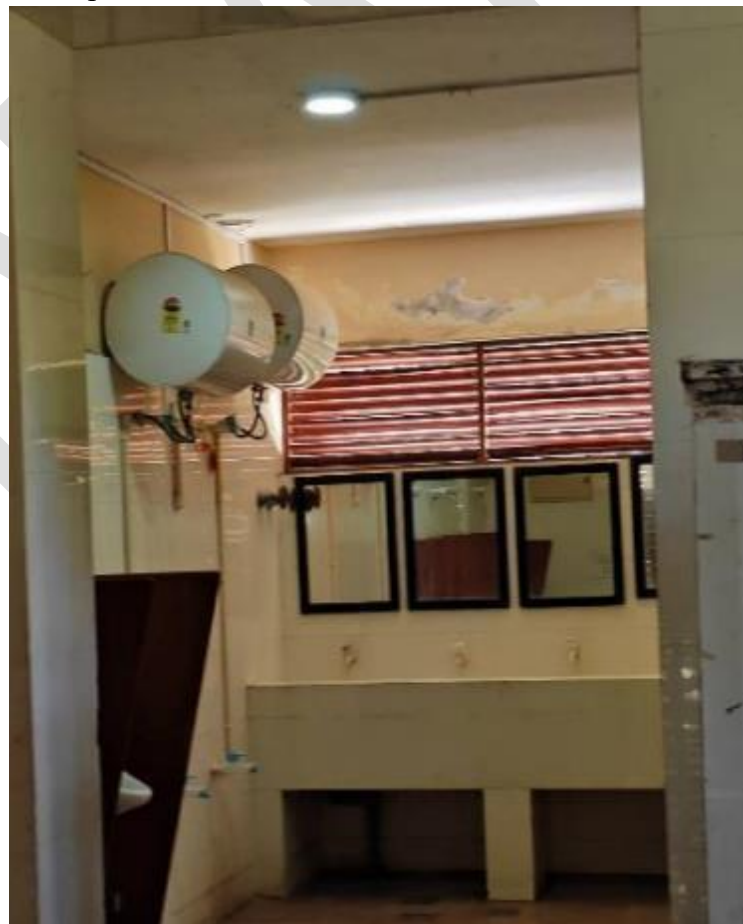
Dampness and Leakage in Washroom area.

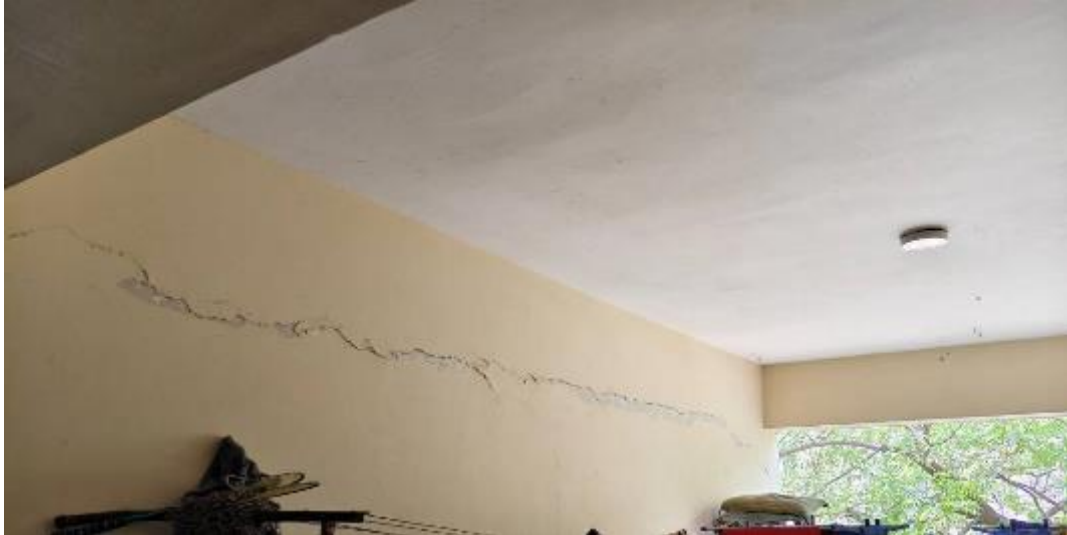
Non-structural Cracks in open chowk and outer walls of rooms

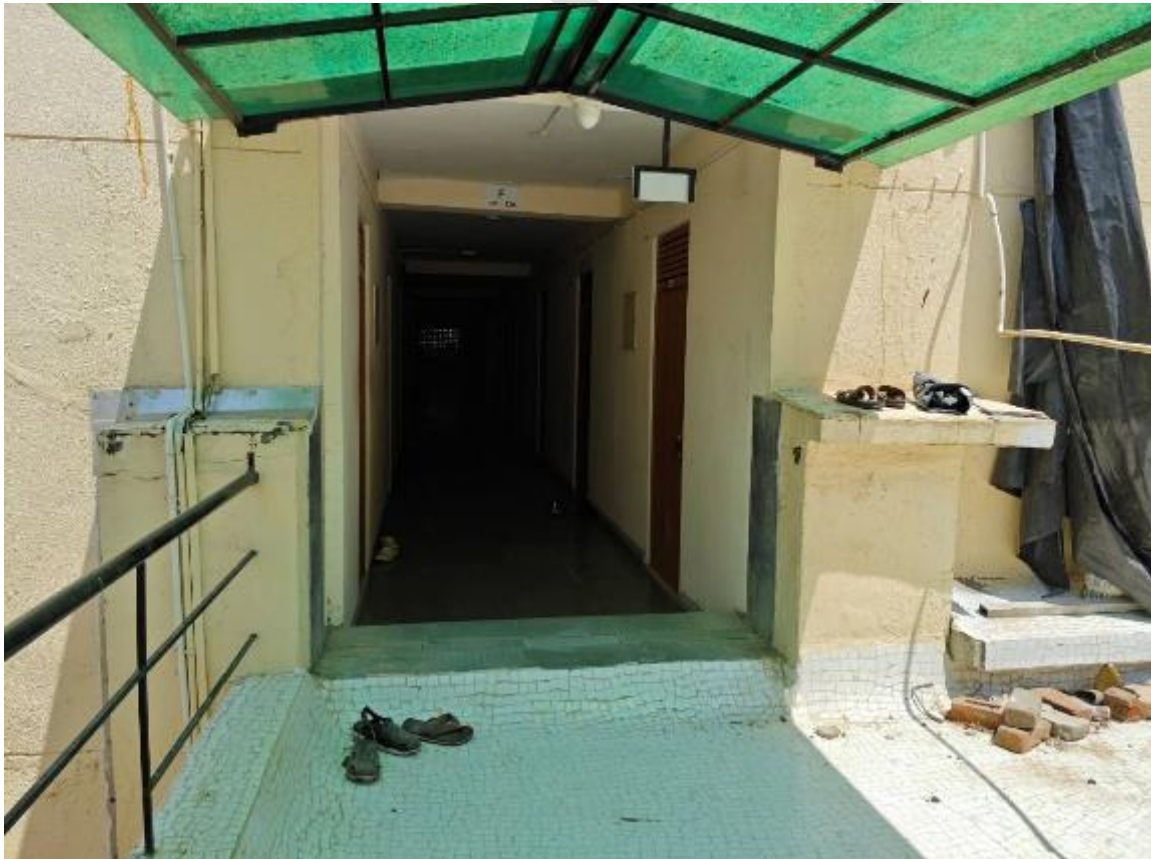
Damages and cracks in Expansion joint water proofing.

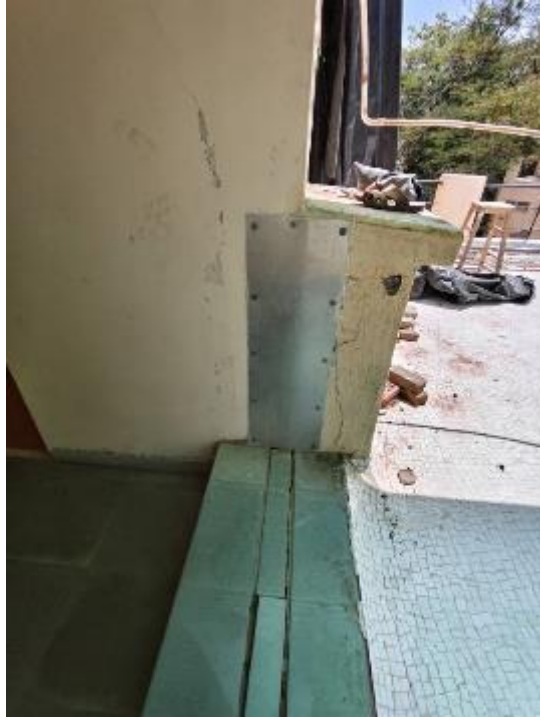
Damages and cracks in Roof water proofing & Expansion joint

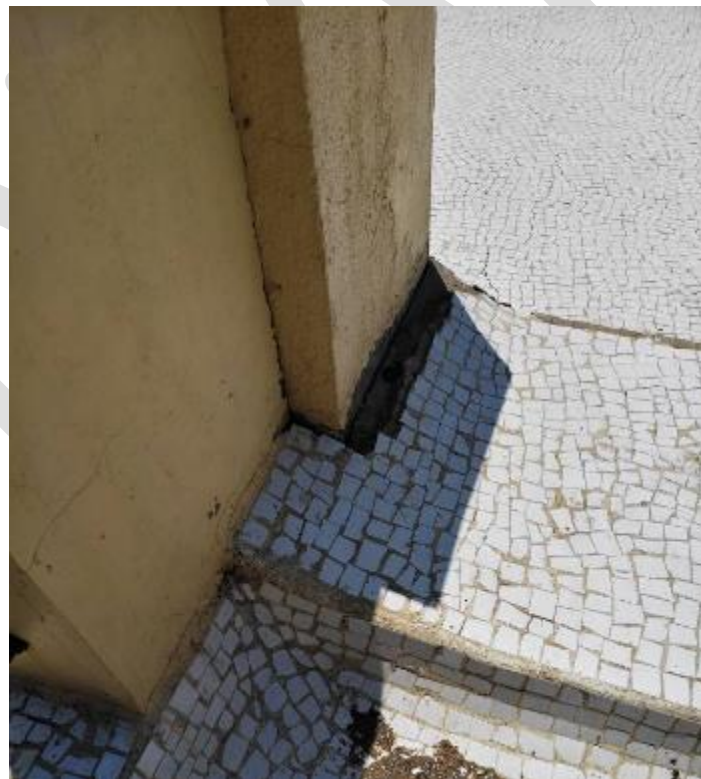
Damages and cracks in Roof water proofing

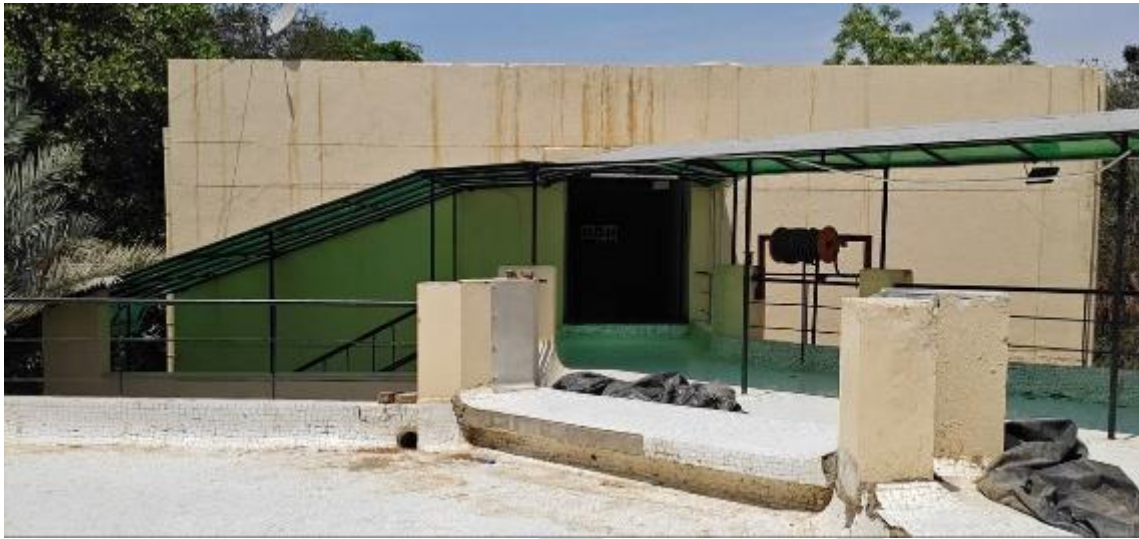
Damages and cracks in Roof water proofing & Expansion joint

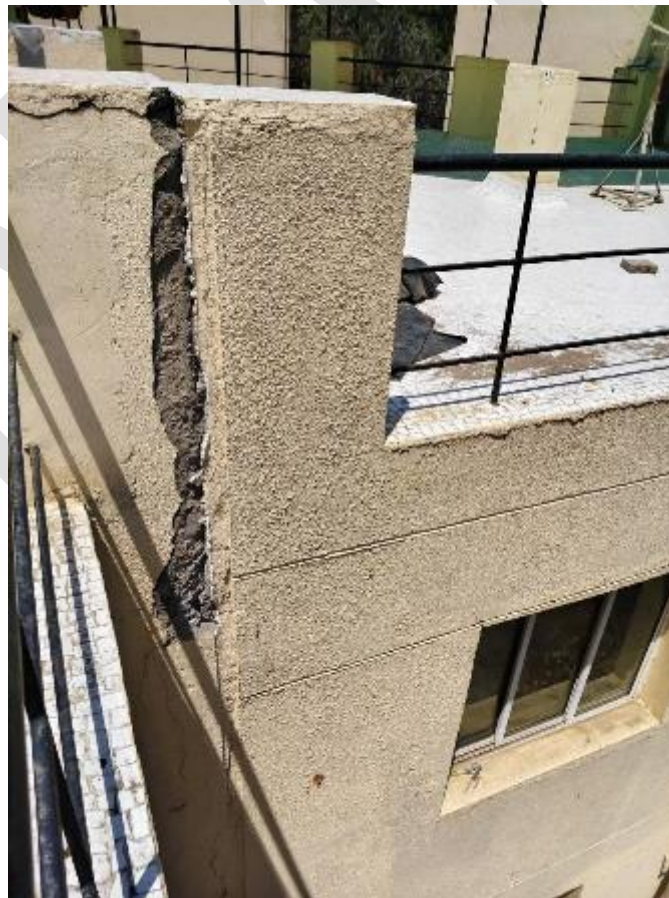
Damages and cracks in water proofing & Expansion joint

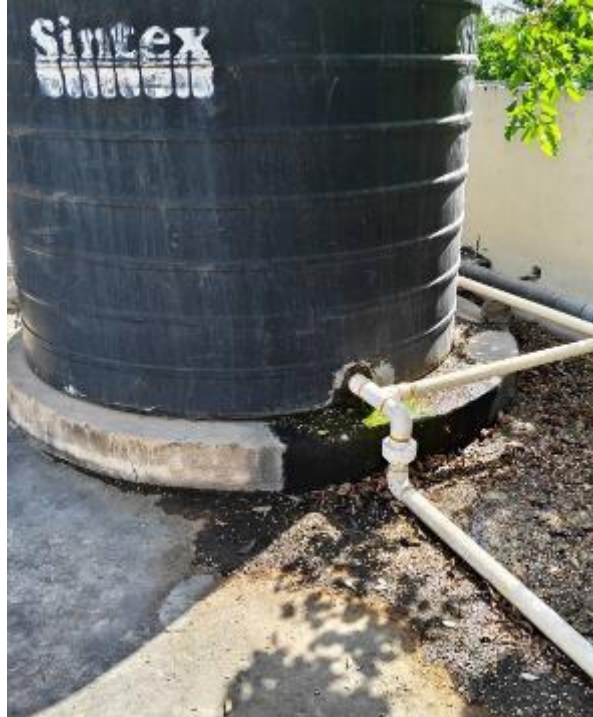
Accumulation of Water and dust near OHWT

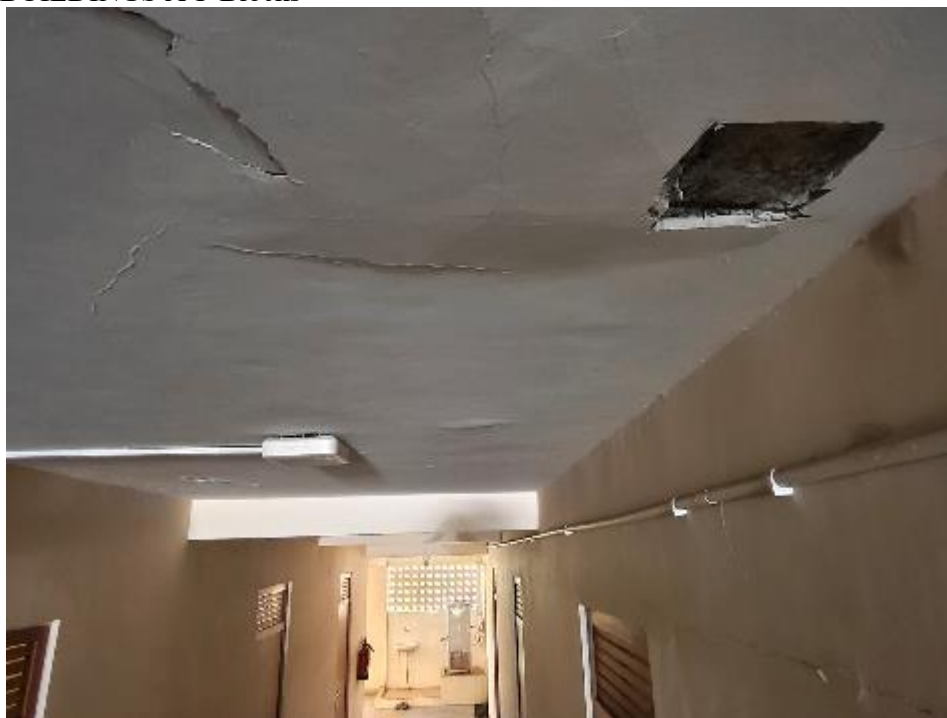
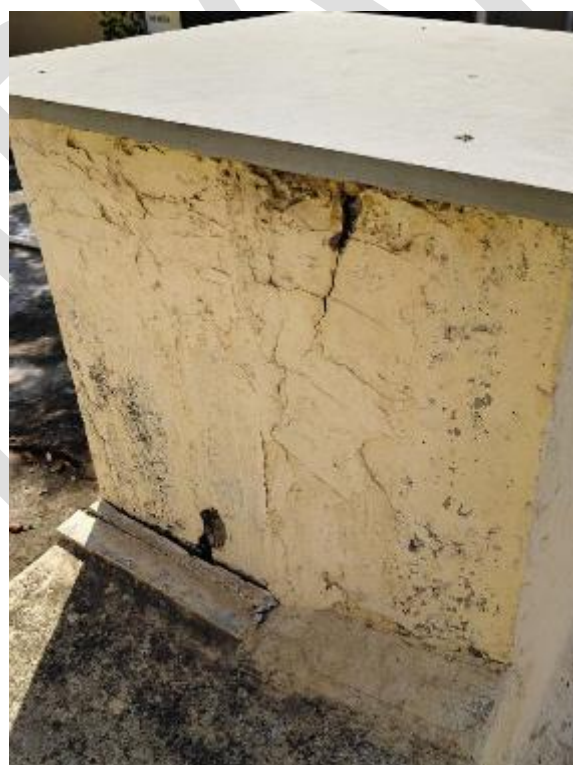
Expansion Joint damage

- **Joints in Floor Slabs:** Clear out all structural debris from the existing gap between the twin RCC beams and roof slabs to insure uninhibited movement. Install a continuous PVC water bar across the joint to create a watertight core barrier against fluid migration. Fill the upper section of the joint gap with a high performance polysulfide sealant to allow structural moment while keeping the interface sealed. Finally, overly the flashing sheet with an 18-gauge Stainless Steel (S.S.) sheet, anchoring it with 30 x 8 mm S.S. screws using explicitly engineered slotted/oblong holes to permit unrestricted structural thermal movement. Additionally, construct a casting in place RCC COPPING (Cap) over the vertical wall extension of the joint line, flashing it with an extra S.S. sheet top fixed with slotted screws to completely shield the core assembly from direct vertical rainwater ingress.

- **Joints in Building and Passage:** Clear out all structural debris from the existing gap between the twin RCC beams and slabs. Install a continuous PVC water bar across the joint to create a watertight core barrier against fluid migration. Fill the upper section of the joint gap with a high performance polysulfide sealant to allow structural moment while keeping the interface sealed. Finally, overly the sloping joint line with an 18-gauge Stainless Steel (S.S.) sheet, anchoring it with S.S. screws through slotted holes on one side to facilitate uninhibited horizontal expansion and contraction. Additionally, construct a concrete weather shed at the top of the building directly over this vertical joint line to shield the entire expansion assembly from direct rainwater ingress.

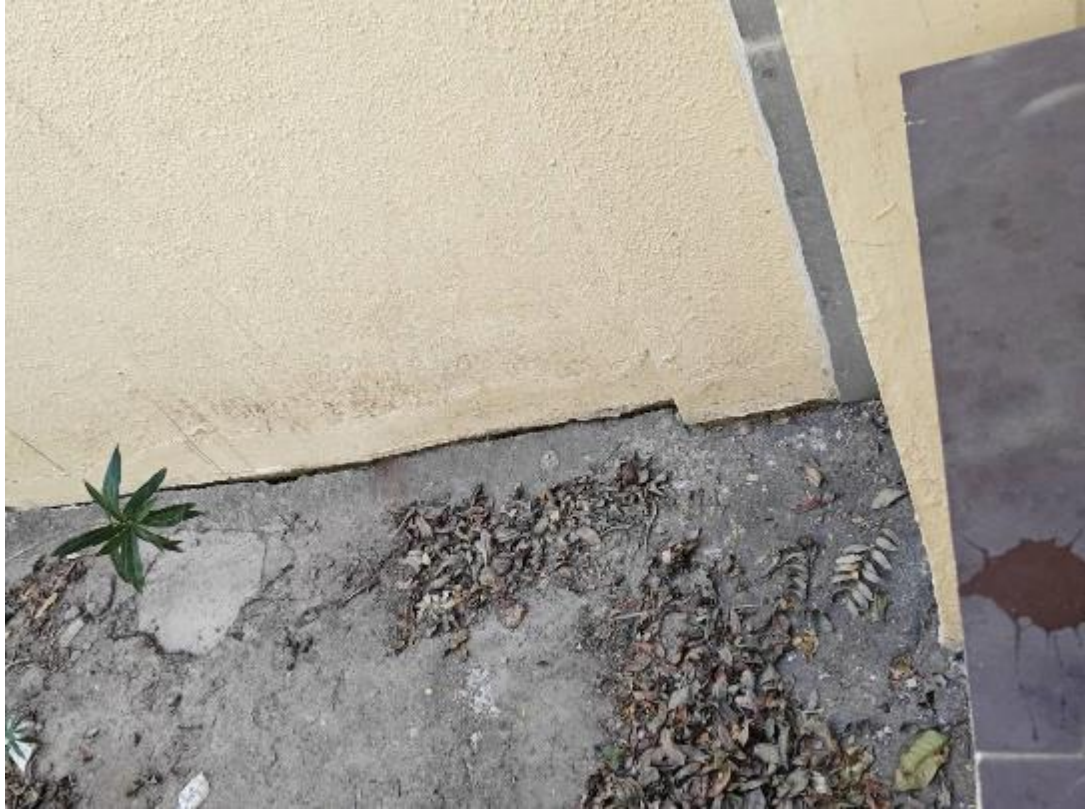
Plinth protection settlement

Plinth protection observed to be settled and damaged at several locations around the hostel building periphery. The following methodology shall be adopted for repair/replacement:

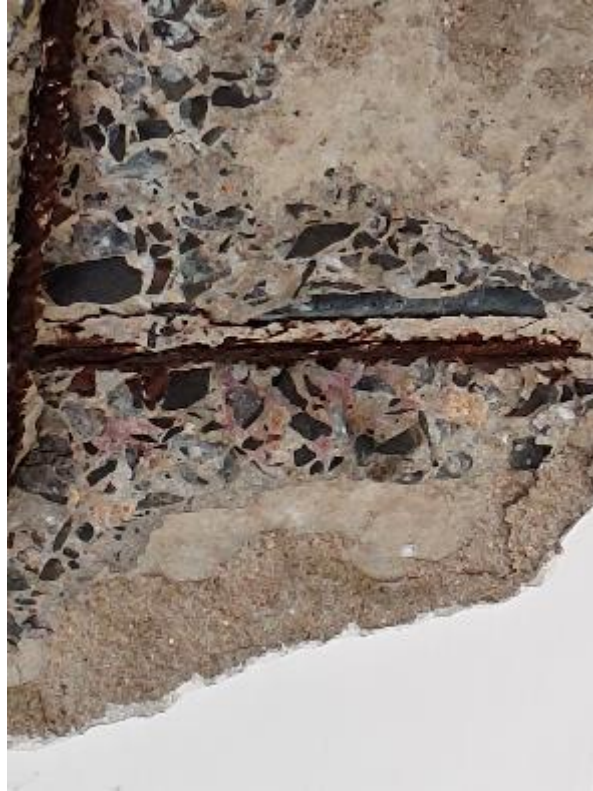
Carbonation at slab Level

- D)** Carbonation testing returned a NOT OBSERVED result at 10 of 11 tested locations, which is a positive durability indicator for the majority of the building. However, carbonation WAS observed at the location opposite D-304 Slab. This finding aligns directly with the weakest rebound hammer readings recorded in that same D Block area, confirming D Block 2nd floor as the single most distressed and highest-priority zone in the building requiring repair before any further assessment of additional loading.
