Final Report on GREEN AUDIT of Dhirubhai Ambani Institute of Information and Communication Technology (DAIICT)

Issue GEMI/GA/683(7)/29/2022

Gujarat Environment Management Institute (GEMI)

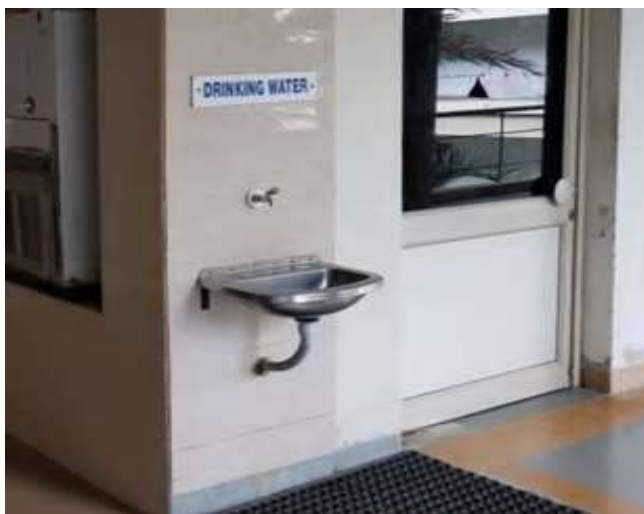
Figure 9 Drinking Water

During the field visit, no leakage/dropping was observed in pipeline/taps. The Institute has provided non-concussive taps for drinking water for conservation of water. For any problem related to plumbing and sanitary works, an in-house maintenance team is kept available for 24X7 hours.

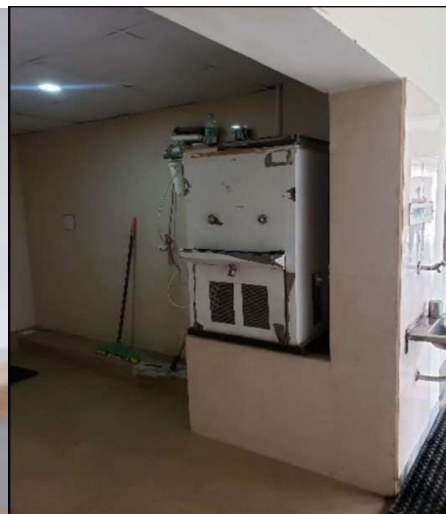
Figure 10 Water Cooler

- ⇒ The Institute has sealed all the water coolers to prevent any direct/indirect contamination of drinking water.

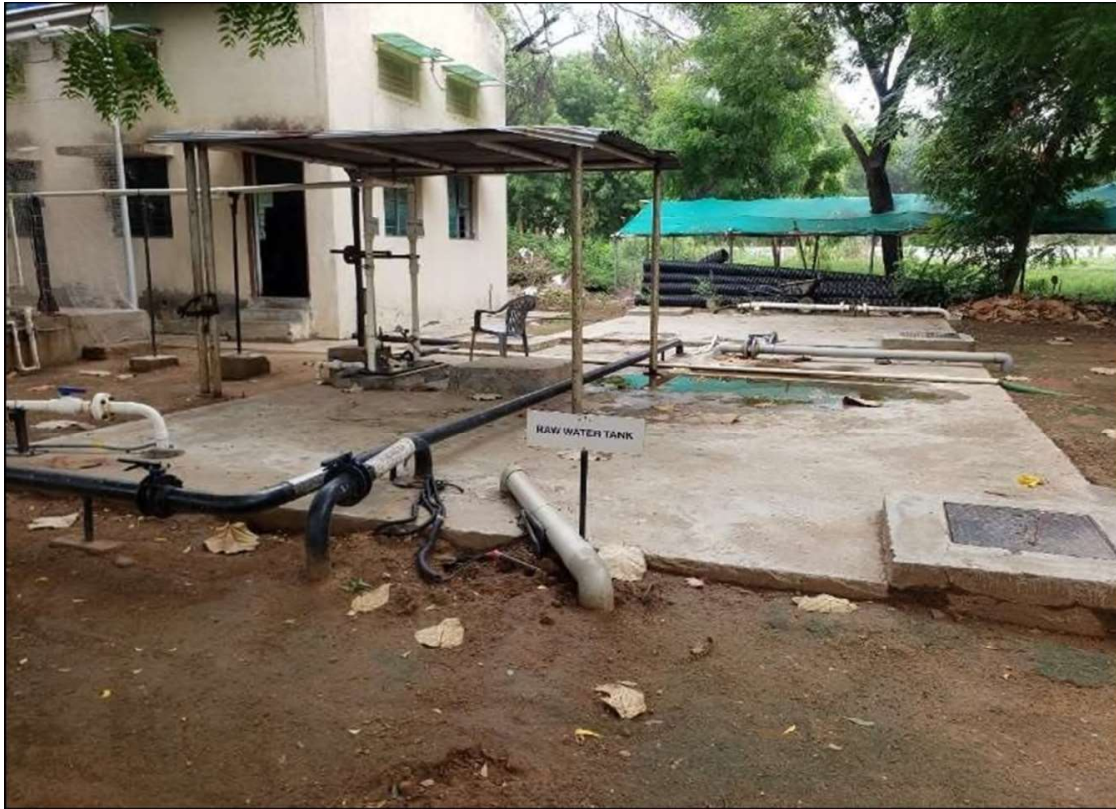
Figure 11 Raw Water Storage Tank

- ➔ The Institute extracts raw water from bore well and stores in raw water storage tank, for which a log book (Annexure-V) for consumption of water is maintained.
- ➔ The Institute has total water storage capacity of 400 KLD (4 Storage tank, each of 1 Lakh Litres Capacity).
- ➔ The storage is adequate in accordance to the water requirement of 230.4 KLD.

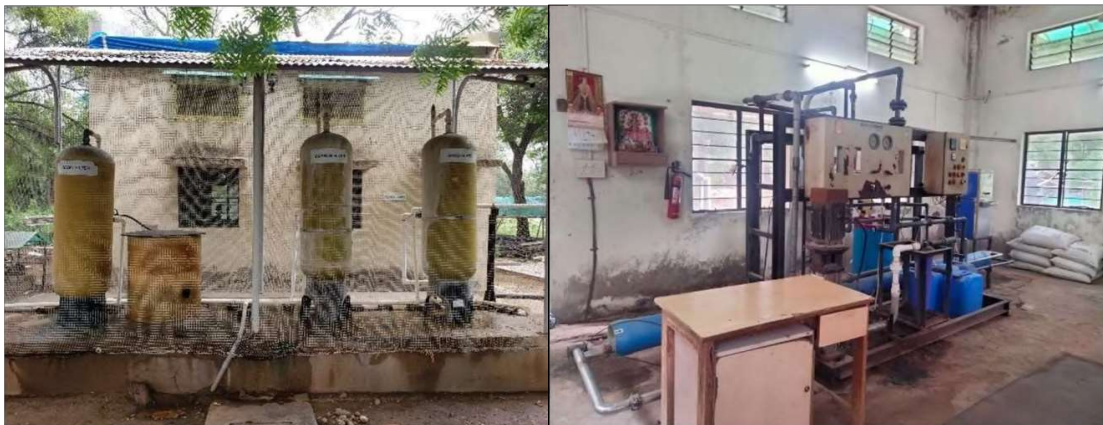
Figure 12 RO Water plant

⇒ Reverse Osmosis (RO) of 6,000 LPH capacity has been provided for treatment of raw water wherein removal of contaminants takes place. The RO system removes contaminants mainly in the form of Total Dissolved Solids (TDS) that includes bacteria, fungi, cysts, virus etc. and also removes some minerals from raw water.

- ⇒ The RO water is supplied to all the buildings of the campus through central pipeline system and RO reject water is utilized for flushing purpose through double piping system.

- ⇒ The quality of raw water and RO water is given in Table - 1 that shows RO system removes about 95% TDS from the water. Moreover, the quality of drinking water shows that values of all parameters are well within the acceptable limits of Indian Standards for Drinking Water (IS 10500:2012) except coliforms.

- ⇒ Presence of coliform bacteria has been found with 80 Colony Forming Unit in 100 mL sample of RO water, which is not acceptable in accordance with the drinking water standards. The bacteriological contamination due to growth of bacteria inside the R.O. outlet pipe may be the reason for the presence of coliform.

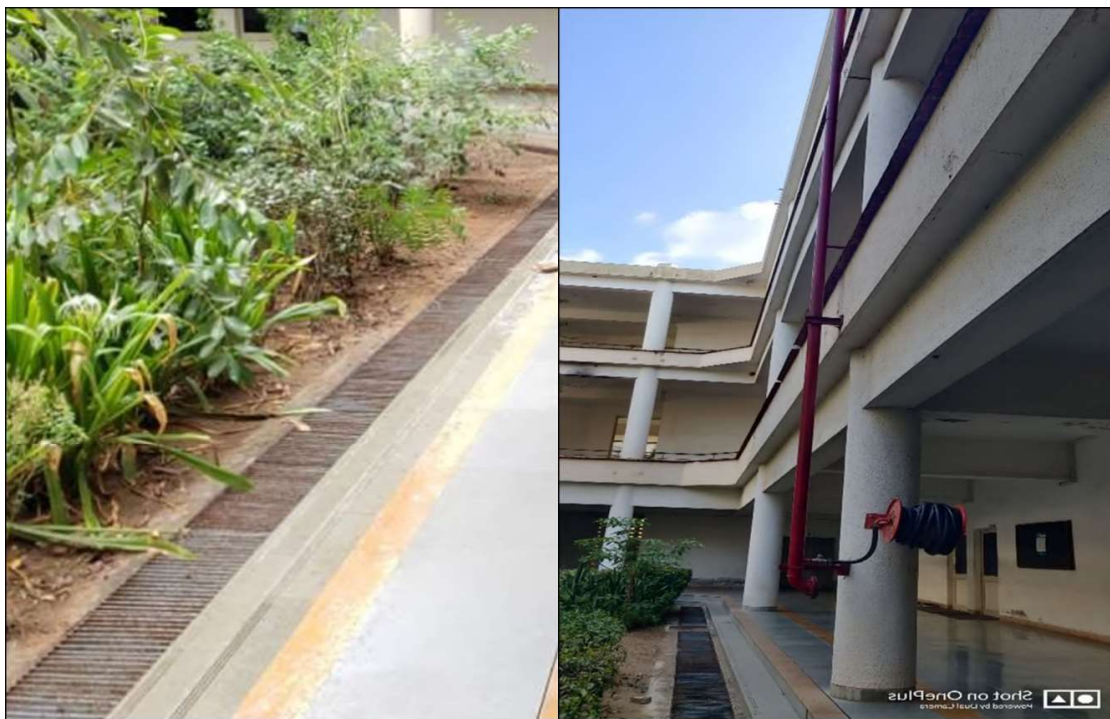
Figure 13 Rainwater Drain

- ⇒ The Institute has a designed drainage system for storm water management but no system for harvesting of rainwater.
